Copper-silver ionization resolves high bacteria levels after failed remediation attempts with hyperchlorination

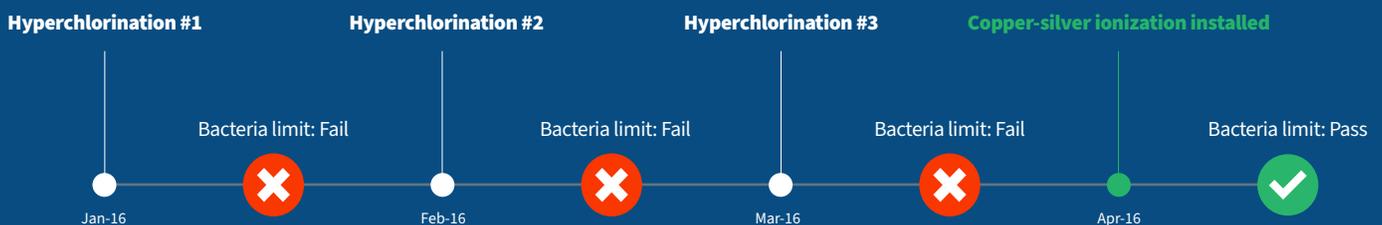
Remediation timeline

Within two months of installing the Copper-Silver Ionization System, test results showed bacteria levels within state and federal EPA limits, allowing the new patient tower to open. The combination of copper-silver ionization, sediment filtration, and LiquiTech's ongoing service partnership has helped the hospital maintain bacteria levels within state and EPA limits since 2016.
